Measuring Motor Shaft Voltage and Bearing Currents with the Fluke 190 Series II ScopeMeter

Application Note

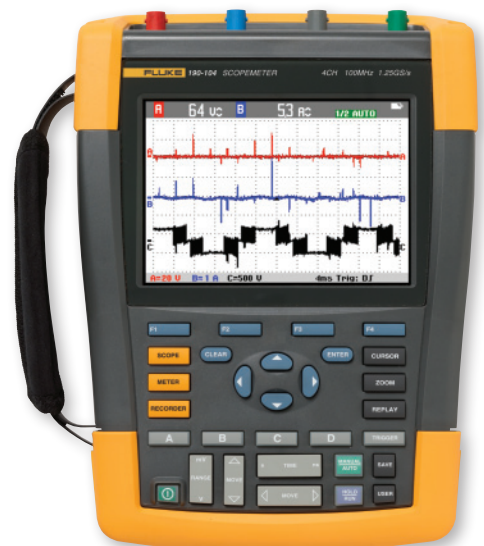
The Fluke 190 Series II ScopeMeter can simultaneously record and display four signals.

Shaft voltage and current spikes caused by the pulse-width-modulated output of motor drives can be exceedingly brief, often in the microsecond measurement range. The high bandwidth (up to 200 MHz) and fast sampling rate (up to 2.5 gigasamples/second) of the Fluke 190 Series II ScopeMeter® make it ideally suited for measuring rapidly changing voltages and currents—far superior to a digital

multimeter. Connect-and-View™ triggering automatically displays stable waveforms with virtually any signal, while ScopeRecord™ enables you to store waveforms in memory for later viewing. And because 190 Series II ScopeMeters can record and display four signals, you can simultaneously view both current and voltage from more than one source.

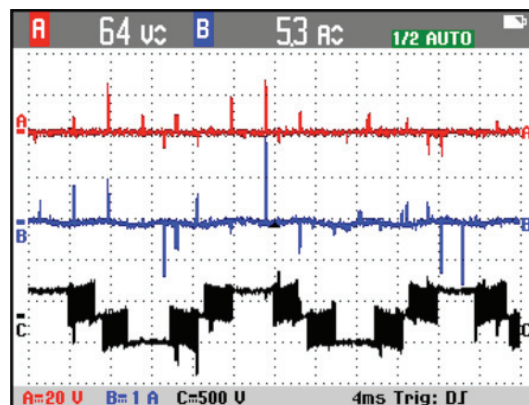
Shaft voltage, common-mode current, and motor drive output displayed on a Fluke 190 Series II ScopeMeter®.

The oscilloscope screen capture shows three measurements that were made with a Fluke 190 Series II ScopeMeter on a motor and drive and are referred to as common mode voltage and current.

All signals were measured on the L1, L2 and L3 line of the Motor Drive.

- Channel A (red trace) shows motor shaft voltage. Spikes can clearly be seen from the flashovers on the shaft through the bearing.
- Channel B (blue trace) shows spikes in the common mode current. The spikes give a clear indication of when a peak occurs, confirming a flash or spark. It is assumed that these currents pass through the bearing.

- Channel C (black trace) shows the output of the motor drive. The quality of this signal determines the efficiency of the motor. A fast rise time in conjunction with a high electrical capacity of the stator/rotor will contribute to the flashovers.

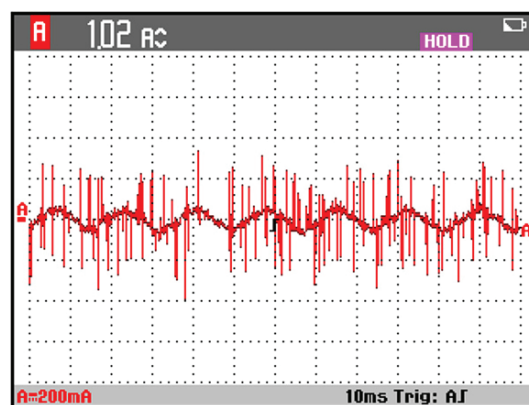
The erratic behavior of sparks can be seen on the captured screen of the Sigma current which is related to the bearing current.

In principle the total current through the L1, L2 and L3 line, referred to as Sigma current, should be equal to the current measured through the Protective Earth, referred to as PE current. In case there is a discrepancy, it is assumed that current is leaking through the bearing caused by parasitic capacitive coupling between the stator and rotor in combination with high frequency circulating currents. Both Sigma current and PE current are made visible on the screen captures.
