Measuring Motor Shaft Voltage and Bearing Currents with the Fluke 190 Series II ScopeMeter

Application Note

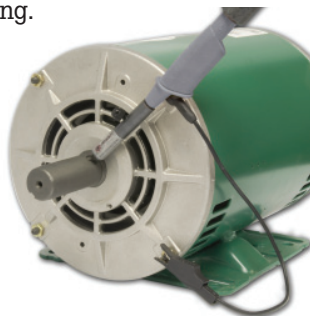
Measuring motor shaft voltage with an Aegis shaft voltage probe (Photo courtesy of Electro Static Technology).

Measuring the voltage of a rapidly spinning motor shaft can be difficult and dangerous. A shaft voltage probe helps to make shaft voltage measurements safer and more convenient by extending your reach, making the electrical connection to a motor shaft by means of a small conductive brush. The reference contact of the probe is connected to ground at the motor housing.

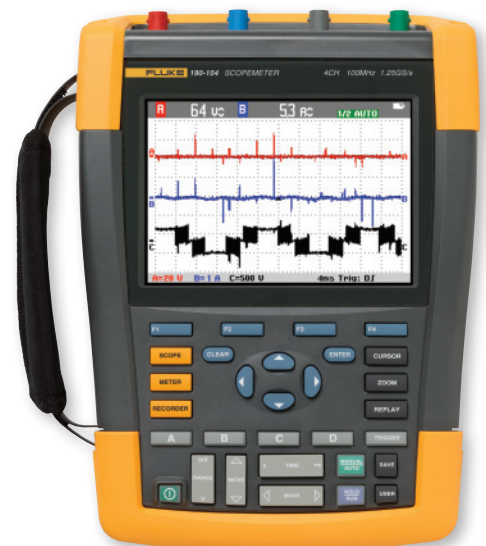
The Fluke 190 Series II ScopeMeter can simultaneously record and display four signals.

Shaft voltage and current spikes caused by the pulse-width-modulated output of motor drives can be exceedingly brief, often in the microsecond measurement range. The high bandwidth (up to 200 MHz) and fast sampling rate (up to 2.5 gigasamples/second) of the Fluke 190 Series II ScopeMeter® make it ideally suited for measuring rapidly changing voltages and currents—far superior to a digital

multimeter. Connect-and-View™ triggering automatically displays stable waveforms with virtually any signal, while ScopeRecord™ enables you to store waveforms in memory for later viewing. And because 190 Series II ScopeMeters can record and display four signals, you can simultaneously view both current and voltage from more than one source.

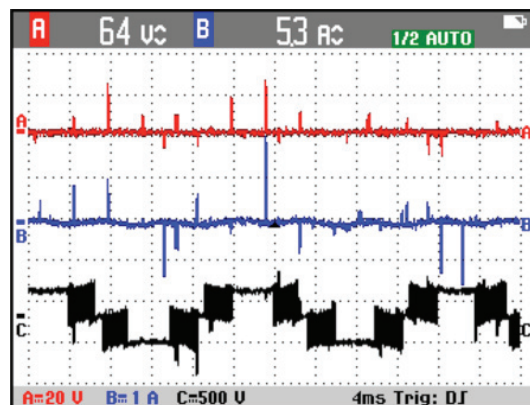
Shaft voltage, common-mode current, and motor drive output displayed on a Fluke 190 Series II ScopeMeter®.

The oscilloscope screen capture shows three measurements that were made with a Fluke 190 Series II ScopeMeter on a motor and drive and are referred to as common mode voltage and current.

All signals were measured on the L1, L2 and L3 line of the Motor Drive.

- Channel A (red trace) shows motor shaft voltage. Spikes can clearly be seen from the flashovers on the shaft through the bearing.
- Channel B (blue trace) shows spikes in the common mode current. The spikes give a clear indication of when a peak occurs, confirming a flash or spark. It is assumed that these currents pass through the bearing.

- Channel C (black trace) shows the output of the motor drive. The quality of this signal determines the efficiency of the motor. A fast rise time in conjunction with a high electrical capacity of the stator/rotor will contribute to the flashovers.
